WES-TR-HL-79-8

4. TITLE (and Subtitle) PROTOTYPE GATE VIBRATION TESTS, BARKLEY DAM, CUMBERLAND RIVER, KENTUCKY		5. TYPE OF REPORT & PERIOD COVERED Final report
6. AUTHOR(s) E. Dale Hart John E. Hite, Jr.		7. CONTRACT OR GRANT NUMBER(s)

PROTOTYPE GATE VIBRATION TESTS, BARKLEY DAM
CUMBERLAND RIVER, KENTUCKY

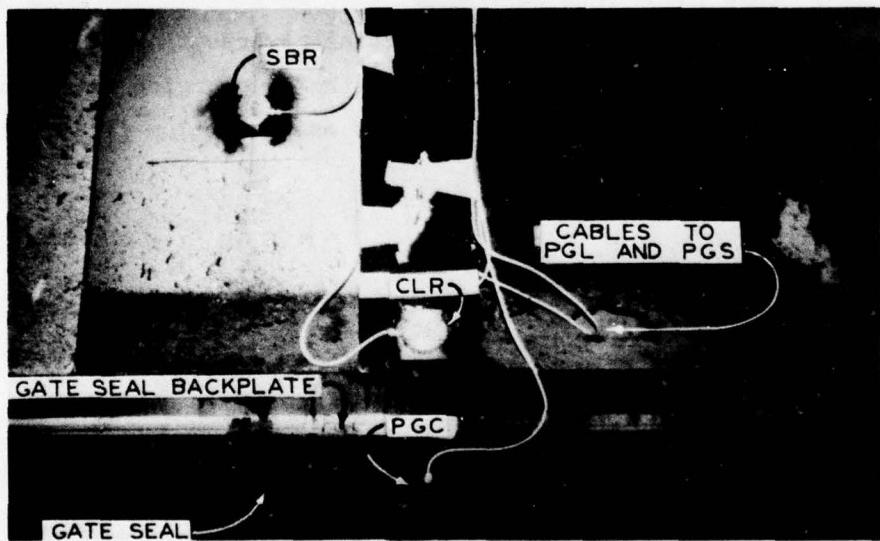
Figure 3. Transducers mounted near the lip of gate 3
(looking upstream)

6. Three 25-psia pressure transducers (PGC, PGL, PGS) were mounted in the lip area of gate 3 as shown in Plate 2. Table 1 lists all transducers, their locations, measurement, and range. The transducers were housed in special adapters and secured with either a locknut or a setscrew. Transducer PGS measured pressure fluctuations on the upstream side of the skin plate about 6 in. above the lip. Transducers PGL and PGC measured fluctuations upstream and downstream, respectively, of the gate seal. In addition, a 25-psia pressure transducer (PGP) was mounted flush with the underside of the lower gate girder in the event gate "bouncing" conditions were experienced. Location of transducers PGC, PGL, and PGS is also shown in Figure 3.

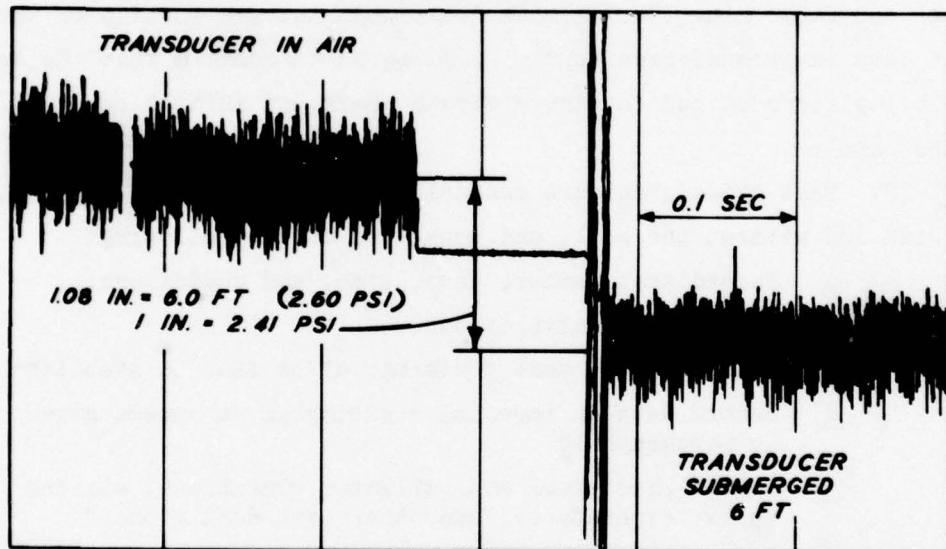
Figure 7. Field calibration of pressure transducer PGS

15. Cutting the pressure transducer cables would preclude their scheduled posttest laboratory calibration. For this reason they were given a check calibration by lowering them to known depths at the test site prior to cutting. The four pressure transducers were lowered to depths of 3 and 6 ft and the resulting trace shift was recorded for comparison with the step calibrations referenced in paragraph 12. Figure 7 presents the shift for transducer PGS at a depth of 6 ft. It differs from the laboratory calibrations by about 4.5 percent.

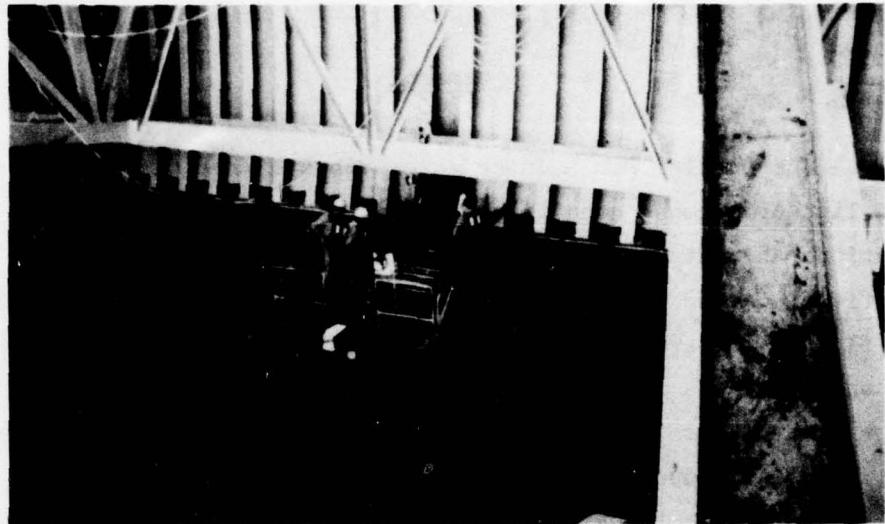
Figure 8. Removing gate 3 seal (looking upstream)

16. The lip seal was removed from gates 3 and 11 for tests 18, 19, and 25 (no-seal tests). This was accomplished by removing the gate seal backplate (Figure 3) while moving across the gate bay on a small barge as shown in Figure 8.

- (1) Removal of the gate seal is an obvious alteration that will reduce vibrations. This procedure is recommended by OCE,³ "...unless water conservation requirements could not tolerate normal leakage."
- (2) If the leakage due to the removal of all seals cannot be tolerated, consideration should be given to removing the seal from a few gates which would be the primary operating gates (for example, the middle four gates).
- (3) Other possibilities include:
 - (a) A narrower rubber seal.

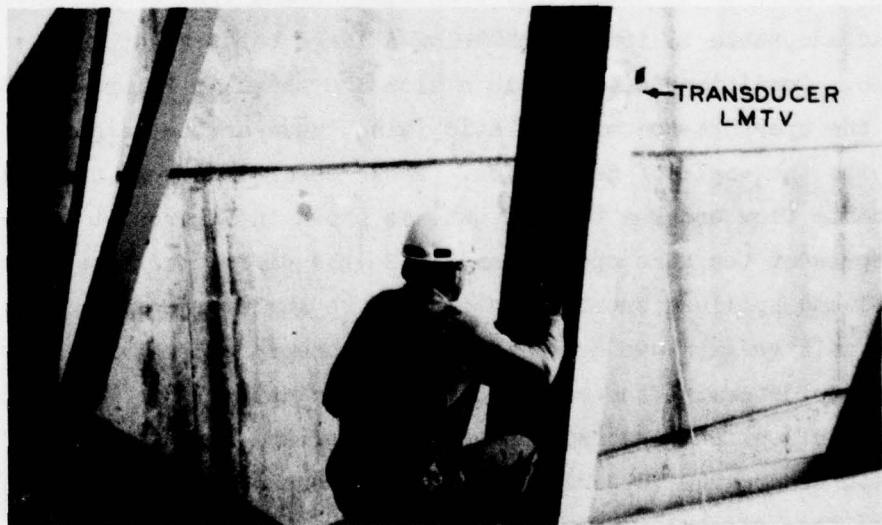
Figure 9. Support member LMTV "ring" test

33. During some of the tests visible vibration of gate support members was noted; an example is the vertical support designated LMTV (Plate 2). An accelerometer was placed on this member and its response recorded during tests 10, 18, and 19 as shown in Table 3. During test 10 a relatively high peak-to-peak displacement of 0.026 ft was recorded. For these three tests the average predominant recorded frequency was 28.6 Hz. The calculated first mode of vibration for a wide flange beam of equal area and length is 22.1 Hz.

34. A "ring" test was conducted by tapping the member LMTV with the handle of a screwdriver as shown in Figure 9. The recorded response is shown in Plate 10. Also shown in the lower left plot is the FFT of this ring test response. Note the first spike at approximately 30 Hz. The lower right plot shows the frequency of response of LMTV during test 10 (also presented in Table 3), again within the area of the calculated natural frequency of the member. Consideration should be given to some form of bracing to alter the natural frequency of this and any other observed oscillating members.

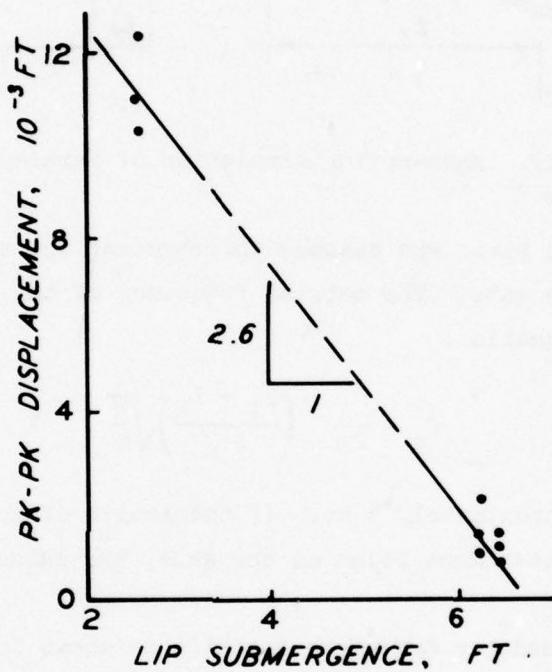
Figure 11. Displacement versus lip submergence

26. Data taken from the transducers common to both gates were used to compute a best-fit line relating vibration displacement and lip submergence. The average slope of this line was found to be -2.6×10^{-3} (Figure 11). This implies that for each foot of increased submergence, gate displacement (pk-pk) decreases 2.6×10^{-3} ft or 0.031 in. Though the relation is not actually linear, it is felt that the graph provides a rough approximation of the submergence-displacement relation at Barkley Dam.

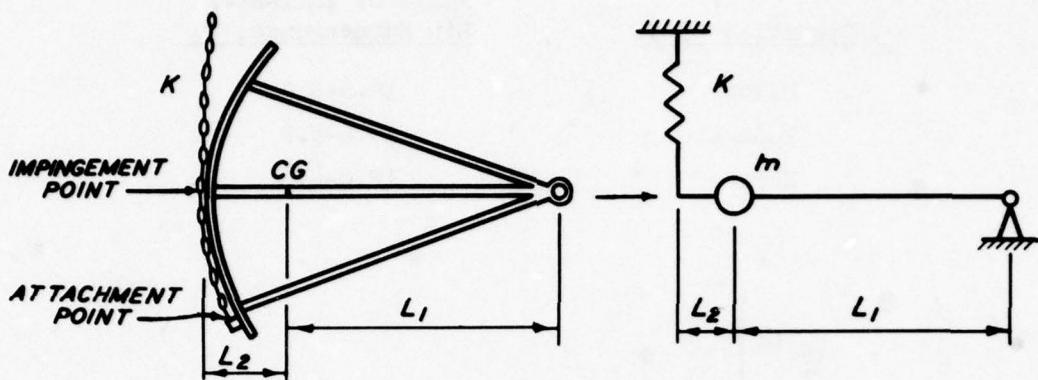
Figure 12. Mass-spring simulation of Barkley gates

chain with the skin plate was assumed to represent the attachment point of the chain to the gate. The natural frequency of the gate was calculated from the equation:

and found to be approximately 5 Hz. If the length of chain is assumed to extend to the attachment point on the gate, the calculated frequency is about 4 Hz.

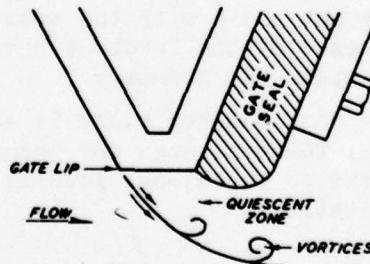
Figure 13. Submerged gate lip conditions

- a. A shear layer forms whenever flow separates from a boundary (as the upstream corner of the Barkley gate lips). Because the innermost portion of the layer moves much slower than the outermost portion, the layers roll up into discrete, swirling vortices (Figure 13).

b. After these initial disturbances are amplified and convected downstream, they interact with the boundaries of the flow field (as, possibly, the gate seal) producing more disturbances. These, in turn, are partially transmitted back to the origin and trigger new disturbances which then proceed through the cycle. Because this is a selective amplification mechanism, the new disturbances result in fluctuations with a much narrower range of frequencies than the original perturbations. With subsequent cycles the fluctuations become more nearly periodic. Thus, interaction of the flow with its boundaries coupled with selective amplification forms what may be described as a "feedback loop." Naudascher¹⁰ summarizes this phenomenon: "Although the fluctuating flow is the origin of the structural vibration, its pattern, periodicity, and intensity are ultimately dominated by the latter, and the vibration becomes sustained by a self-generated exciting force."

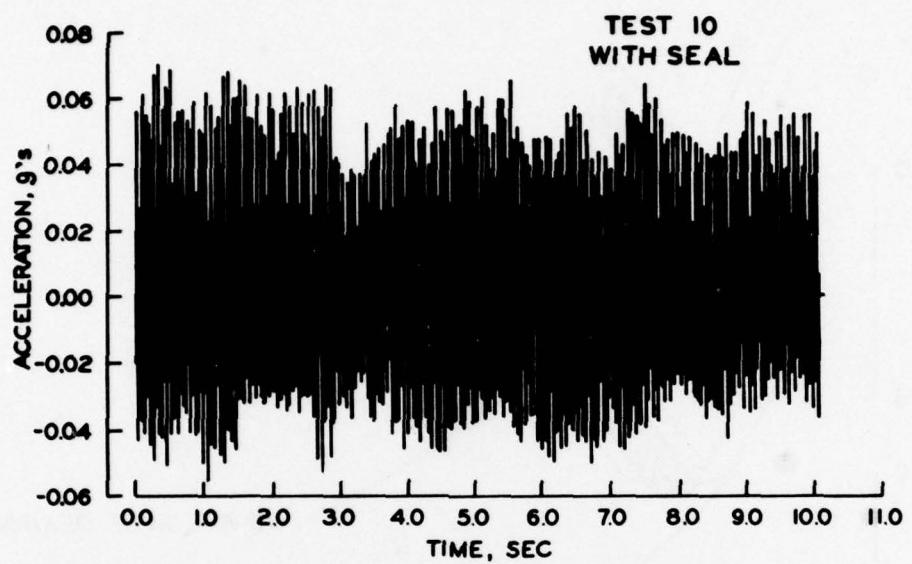
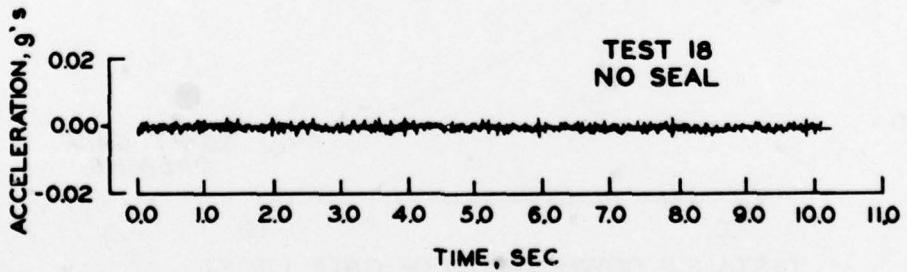
24. The effect of seal removal is further illustrated by results from the time series analysis of the magnetic tape data. Plate 4 presents a comparison of accelerations for identical conditions except for seal removal. These data are from transducer CMP which was mounted in the gate center near the skin plate (Plate 2) and responded to movement tangent to the skin plate thereby representing gate movement in the

vertical plane. The probability density plots of Plate 5 indicate that the probability of a particular acceleration occurring is considerably higher with the seal than without. For example, the probability of experiencing an acceleration of ± 0.02 g's with the seal in place is about 5 percent. Without the seal this level of acceleration is almost nonexistent. Finally, in Plate 6 the test 10 (with seal) cumulative distribution function (CDF) indicates a 95 percent probability of an acceleration of approximately ± 0.12 g's or less occurring with the seal in place. The CDF for the no seal condition shows a 95 percent probability of ± 0.004 g's or less occurring. Thus the seal/no seal ratio for the 95 percent probable acceleration is 30.0.

GATE ACCELERATION INTENSITY
TRANSDUCER CMP
GATE 3, GATE OPENING 4.2 FT

GATE ACCELERATION
PROBABILITY DISTRIBUTION
GATE 3, GATE OPENING 3.6 FT

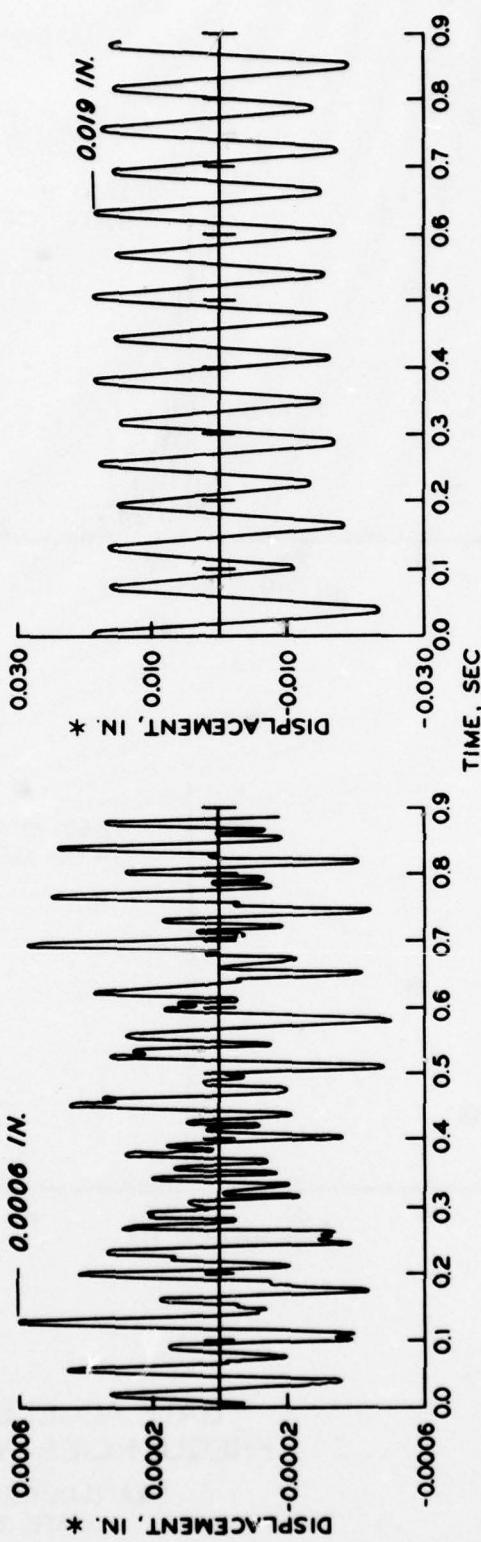
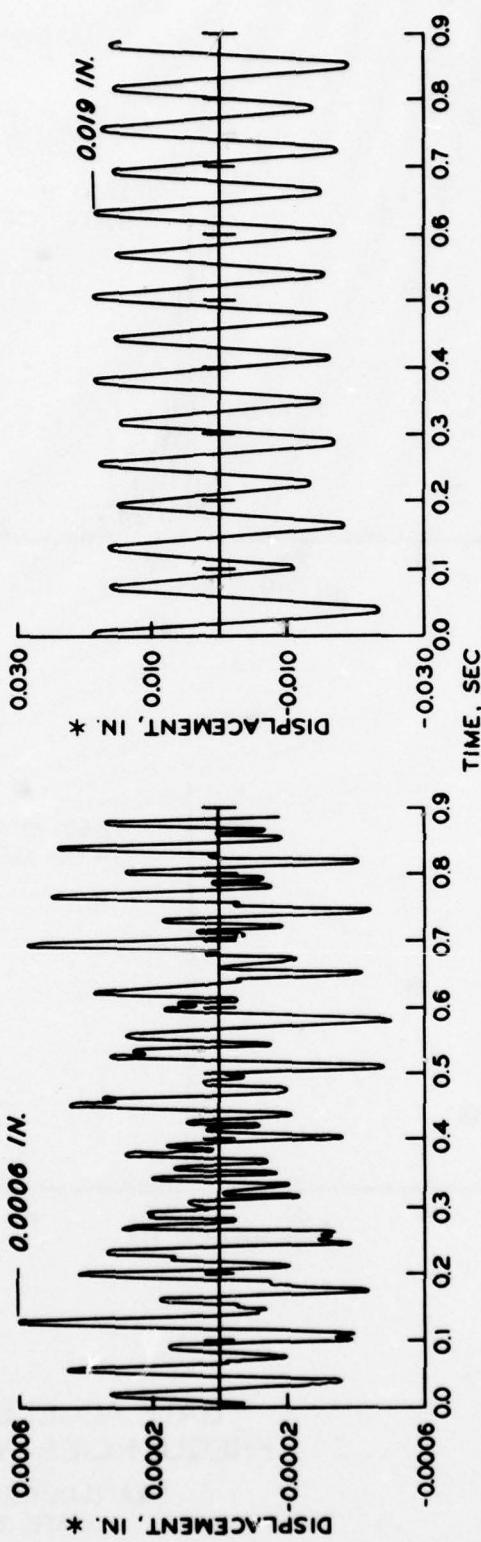
25. Table 3 and Plate 7 show that vibration displacements recorded at gate 11 (tests 24 and 25) are higher in all cases than the corresponding transducer recordings for gate 3. Table 2 indicates that head differential is almost identical for all tests. Gate 3 openings, however, are about half those of gate 11, creating a gate 3 to gate 11 tailwater gate lip submergence ratio of about 2.5 to 1. It would then appear that gate lip submergence and vibration intensity are related.

TAILWATER SUBMERGENCE
DISPLACEMENT COMPARISON
TRANSDUCER CTR

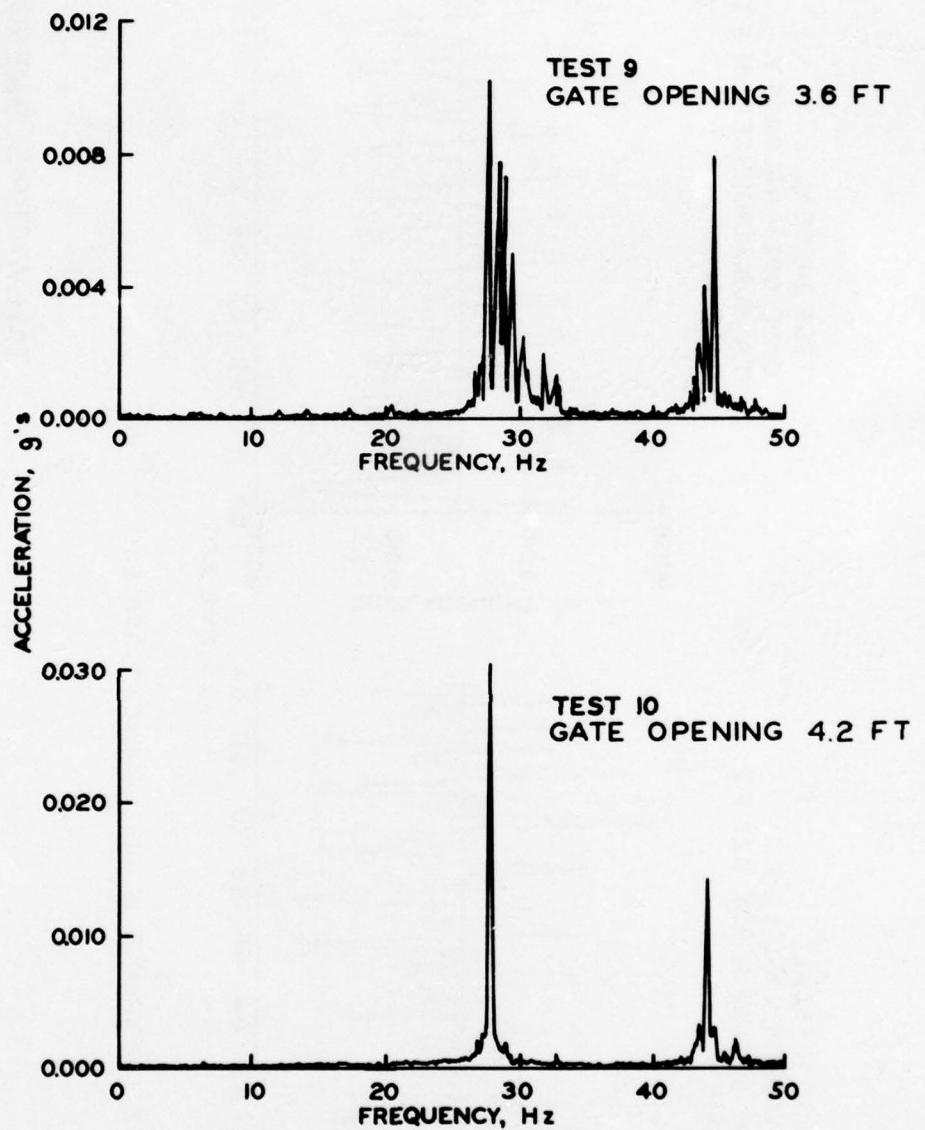
30. In all four plots of these two plates, prominent frequencies appear as isolated spikes. The more prominent of these occur during tests 9 and 10 in which the seal was in place. In both of these tests

the prominent frequencies were about 29 and 44 Hz, the former corresponding closely to the gate lip pressure fluctuations which will be discussed in a subsequent section (paragraph 40).

GATE ACCELERATION
FREQUENCIES (WITH SEAL)
TRANSDUCER CMP
GATE 3

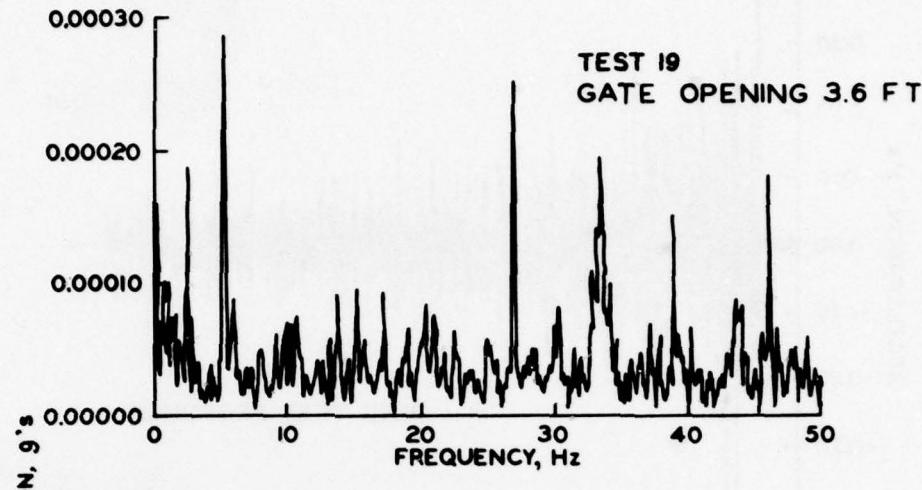
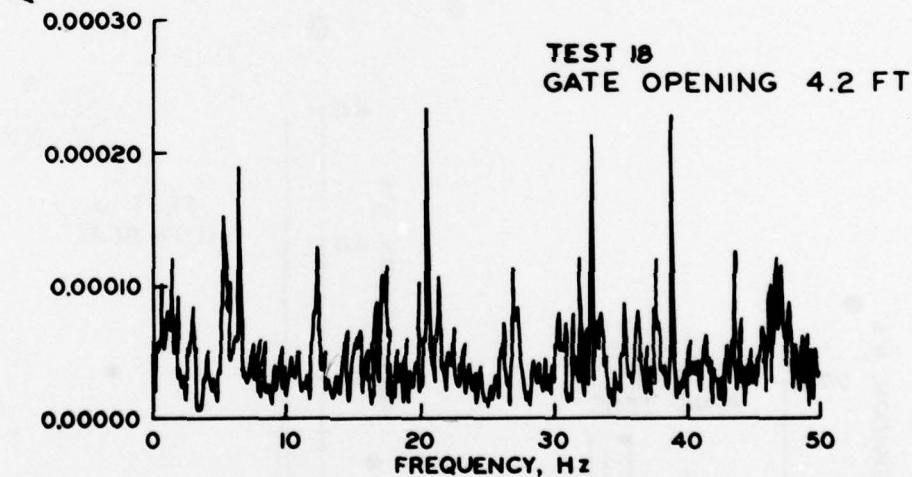
PLATE 9

GATE ACCELERATION
FREQUENCIES (NO SEAL)

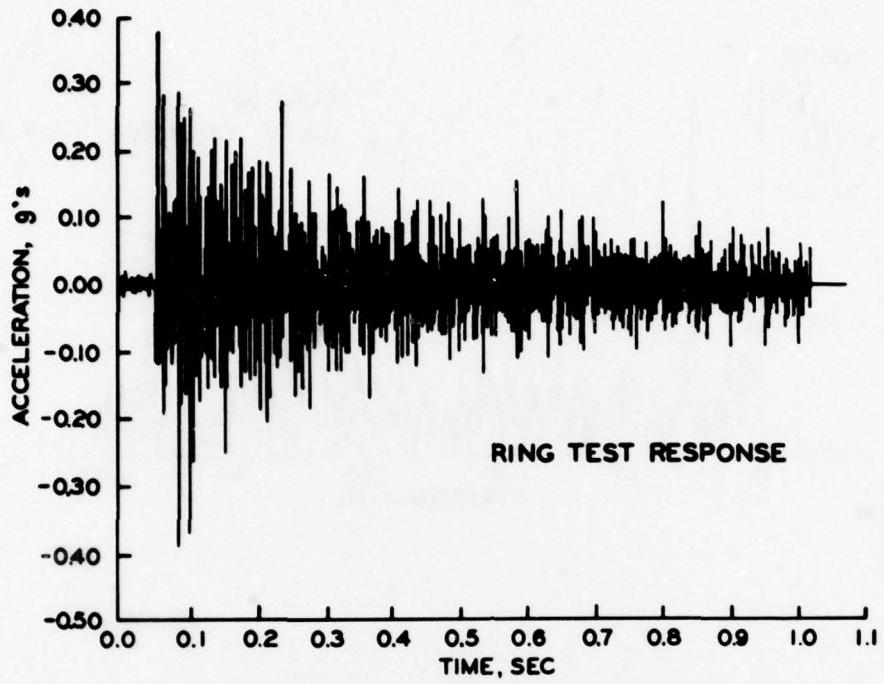
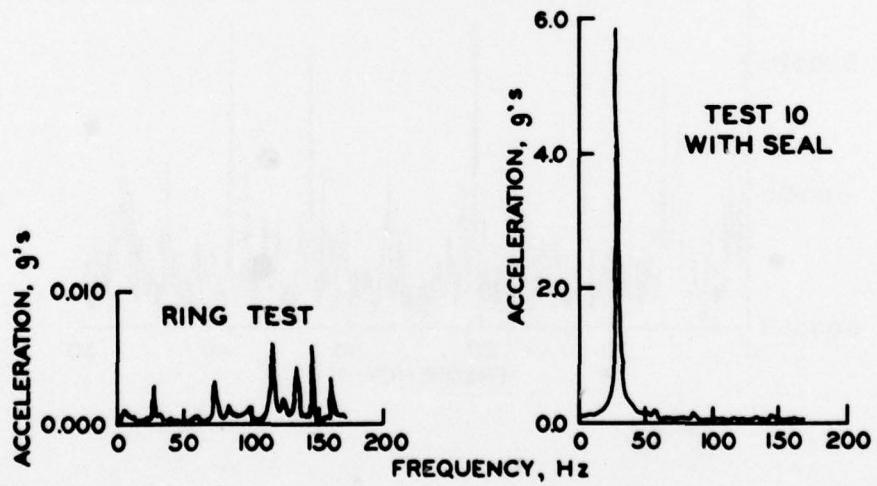
PLATE 10

SUPPORT MEMBER LMTV
RESPONSE
GATE 3

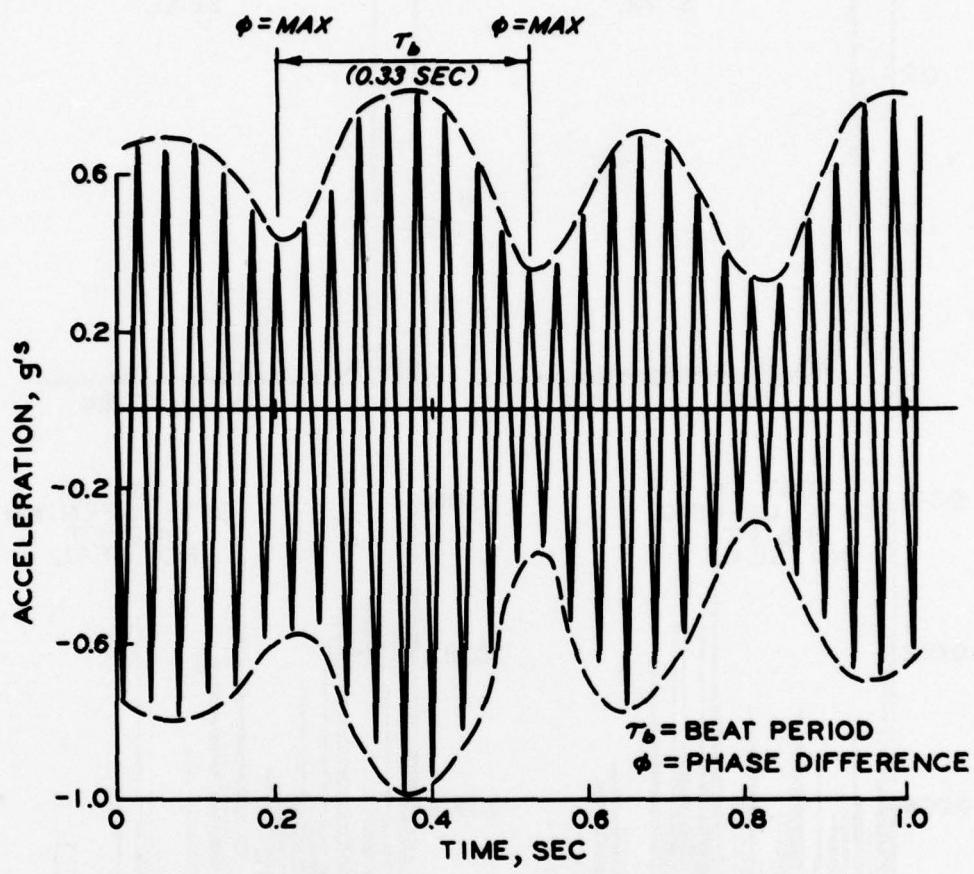
37. The amplitude envelope shown in Plate 11 fluctuates at a rate

From Plate 11 τ_b was determined to be 0.33 sec so that $f_b = 3.05$ Hz.

In other words f_n and f_f differ by this amount, being in (and out of) phase every 0.33 sec. From Equation 2 the natural frequency at the point of transducer LMT can be found to be 32.4 Hz. (The forcing frequency f_f , for transducer PGL was measured to be 29.3 Hz.)

ACCELERATION BEAT FREQUENCY
 TEST 8, GATE 3, GATE OPEN 4.2 FT
 TRANSDUCER LMT

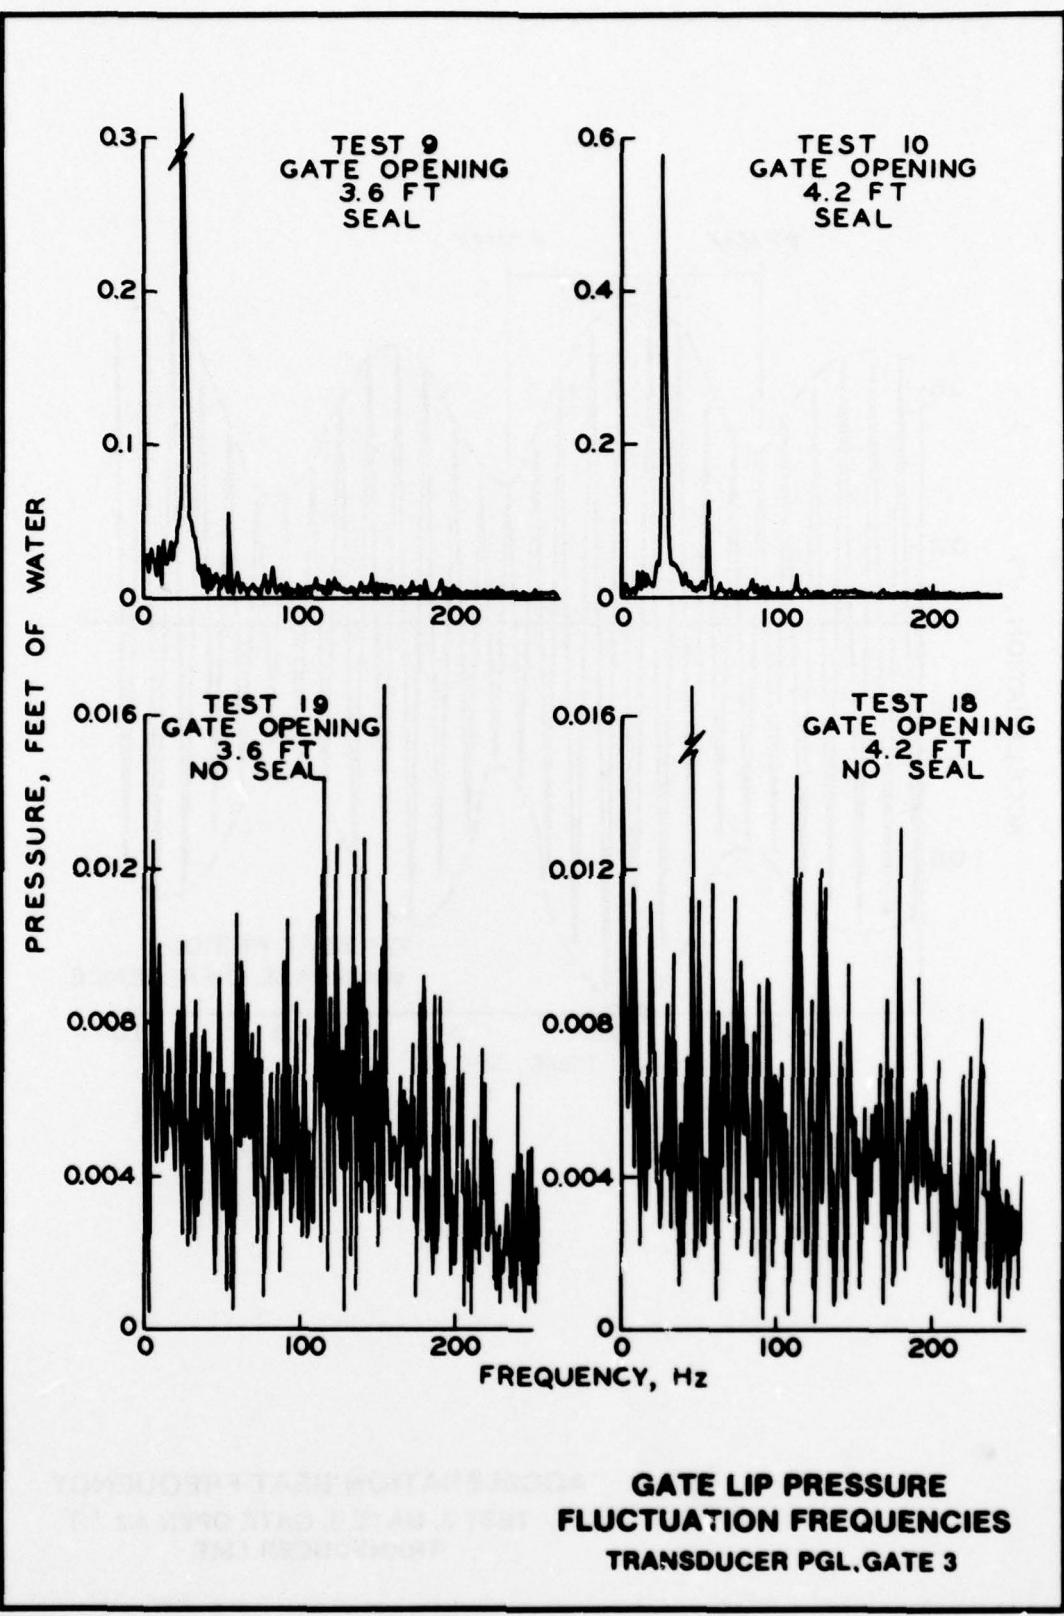
PLATE 12

40. Plates 8 and 12 show that with the gate seal in place the gate vibrates and the pressures fluctuate at a discrete, common frequency of about 30 Hz. On the other hand, with the seal removed, Plates 9 and 12 show that the oscillations are more random and of small magnitude. A cross-spectral density calculation of transducers CMP (gate acceleration) and PGL (gate lip pressure fluctuations) was made and the plot is shown in Plate 13. The very prominent spike at 28.3 Hz implies a strong correlation at that frequency. As an additional check, short-time history segments of these two recorded signals were arbitrarily selected from test 10 (seal in place) and plotted as shown typically in Plate 14. The phase shift ϕ between the two phenomena was constant within a range of ± 5 percent for all segments evaluated.

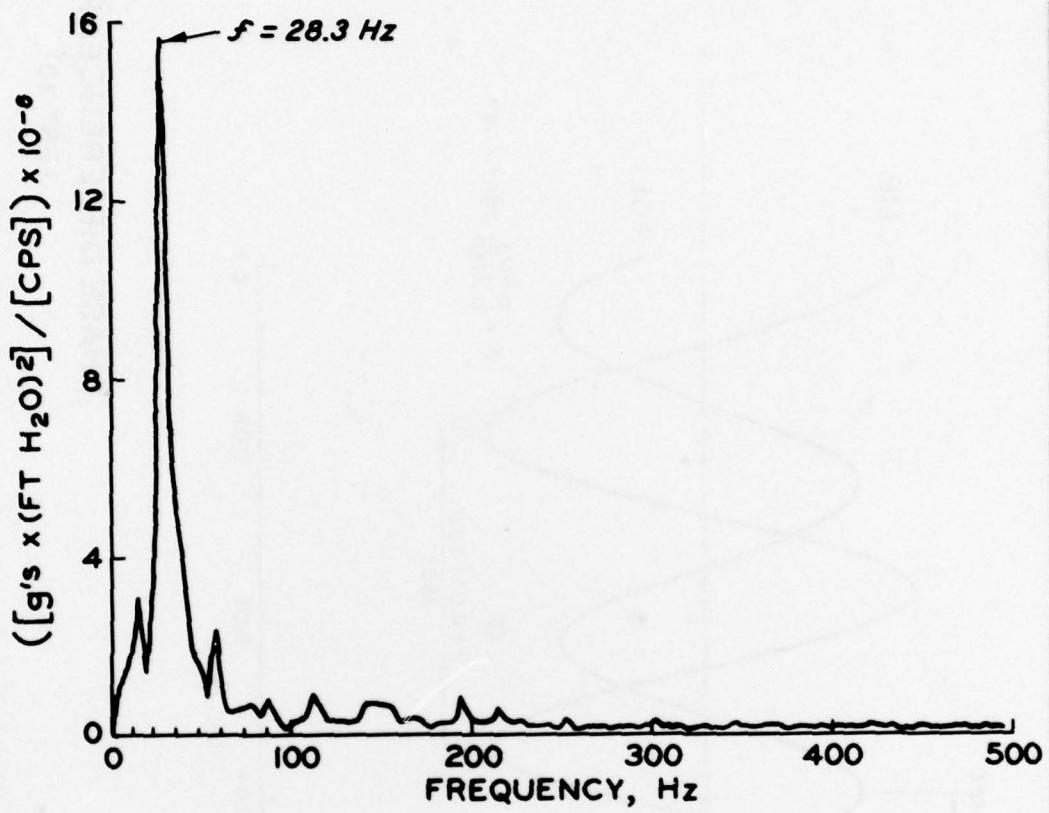
SPECTRAL DENSITY PLOT
TRANSDUCERS CMP AND PGL
TEST 10, GATE 3, GATE OPEN 4.2 FT
(SEAL IN PLACE)
